Colorado State Capitol Dome Exterior Restoration Project

May 3, 2012

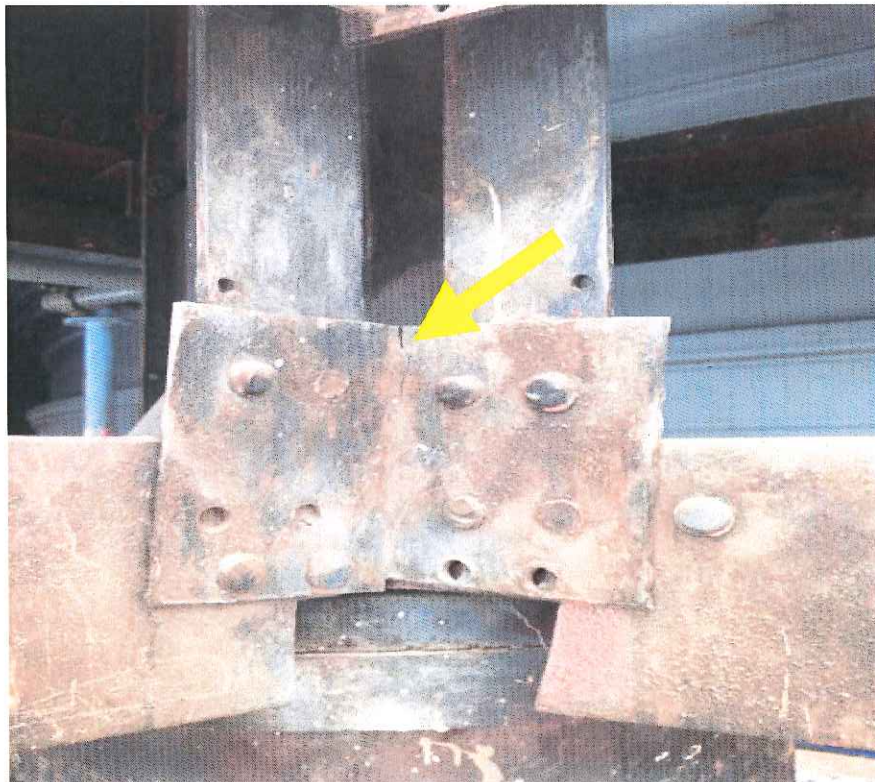
Photo 07.7: Cracked angle

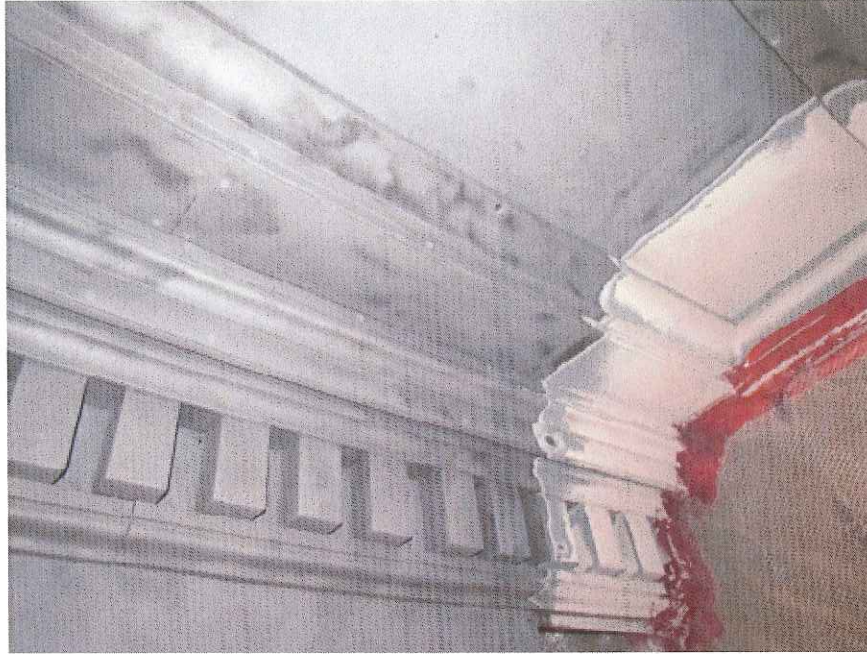
Photo 07.6: Cleaning of soffit below upper terrace

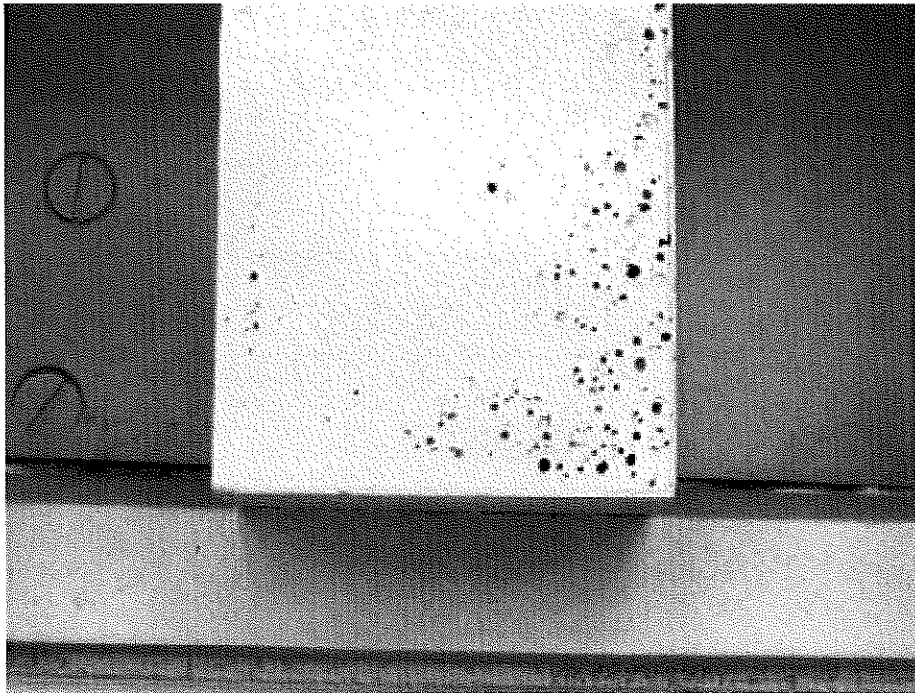
Photo 07.3a: Porosity on cast iron

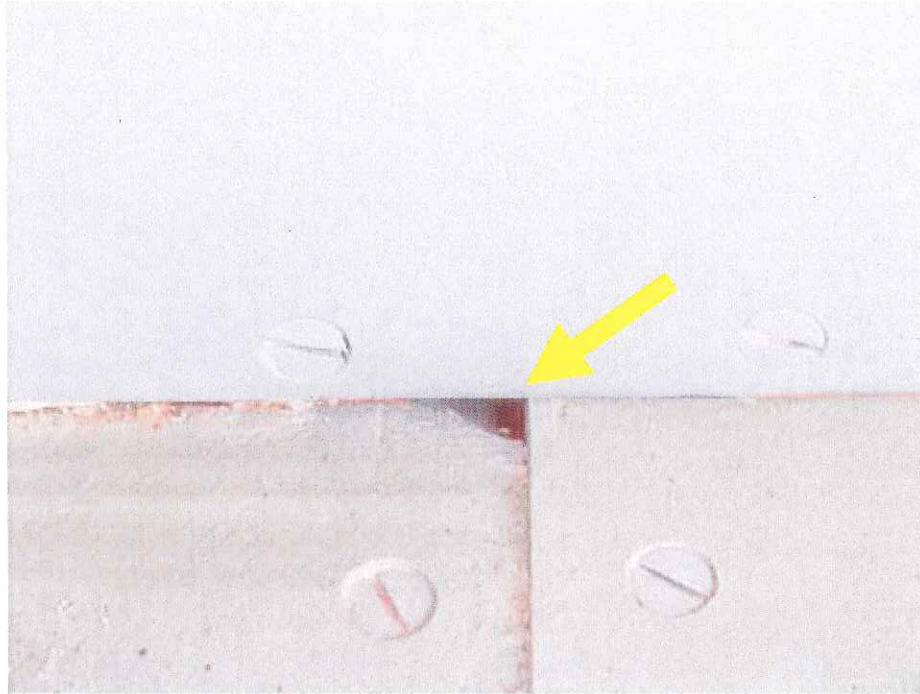
Photo 07.3b: Chipped corner on cast iron

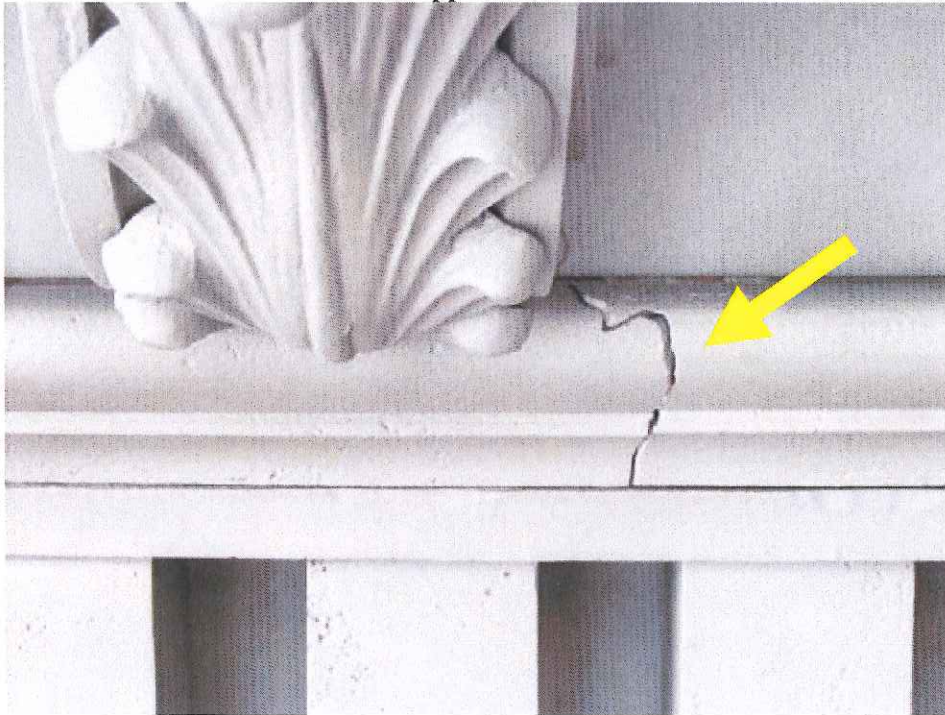
Photo 07.3c: Crack in piece LD-E-10

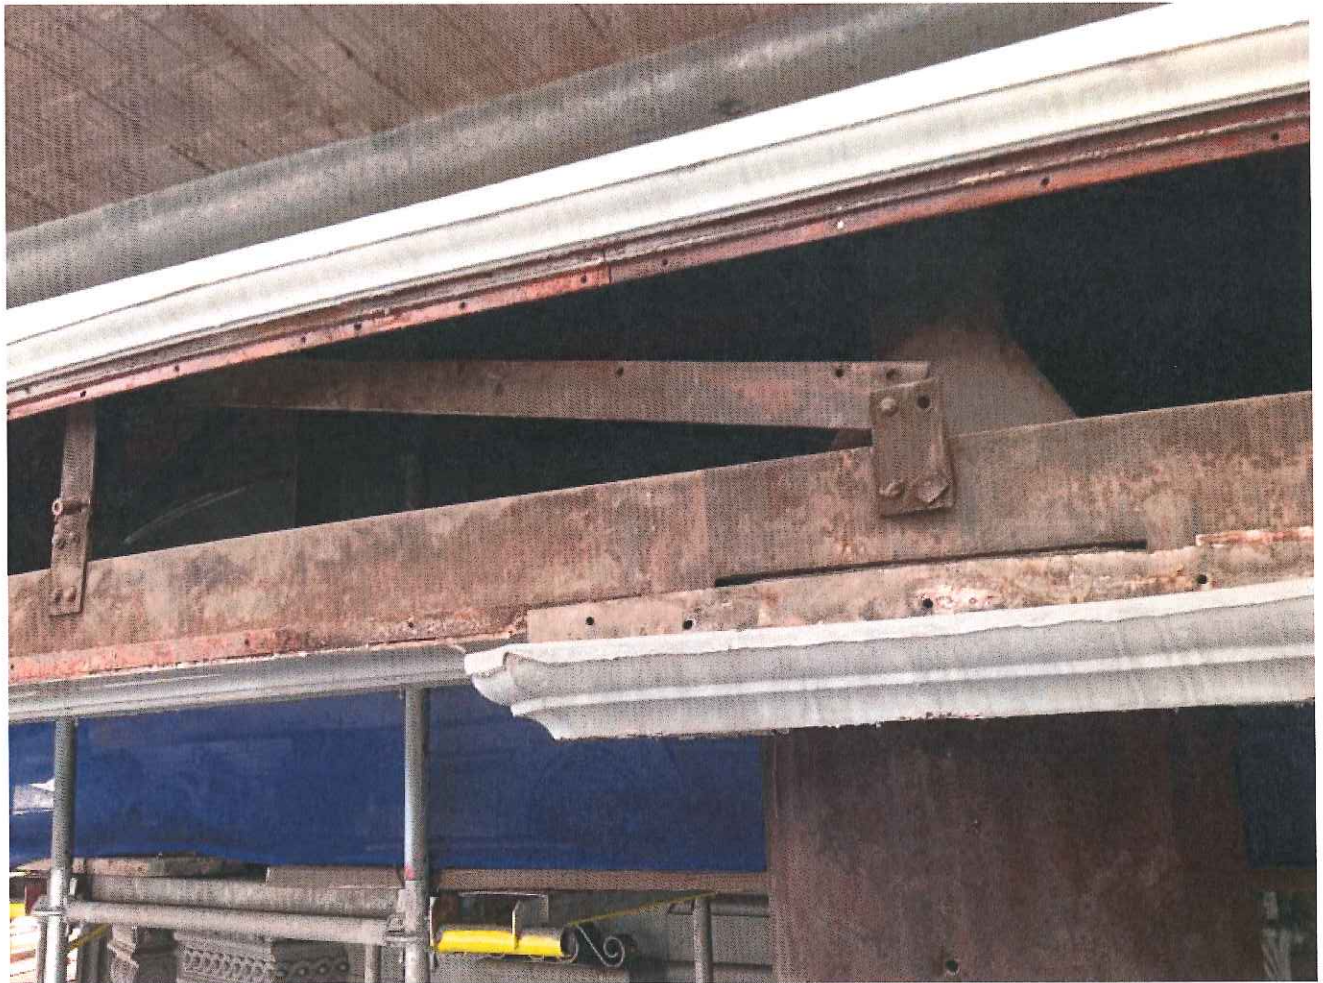
Photo 09.2: Disconnected hanger at grid line C

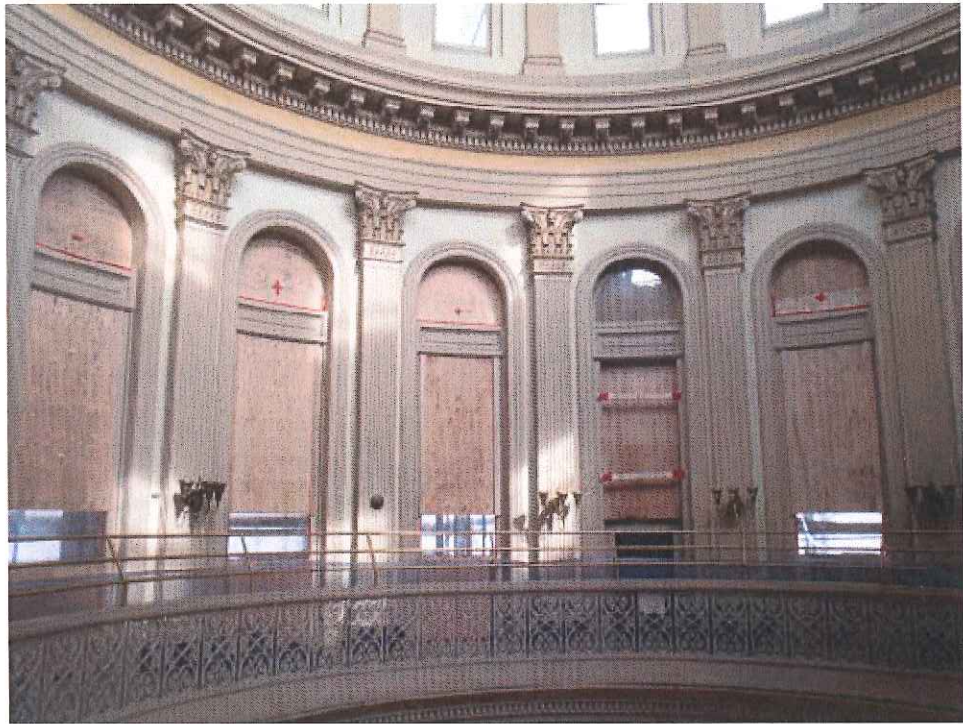
Photo 1.9: Installed window protection – observation deck.

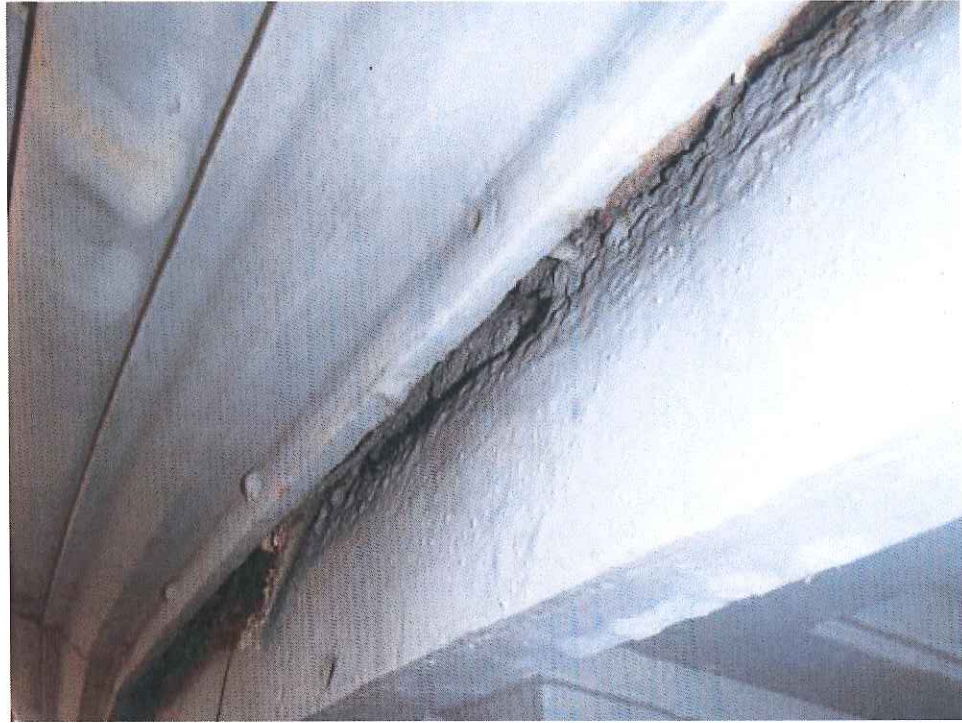
Photo 1.6a: Gutter profile pulling away from vertical plate.

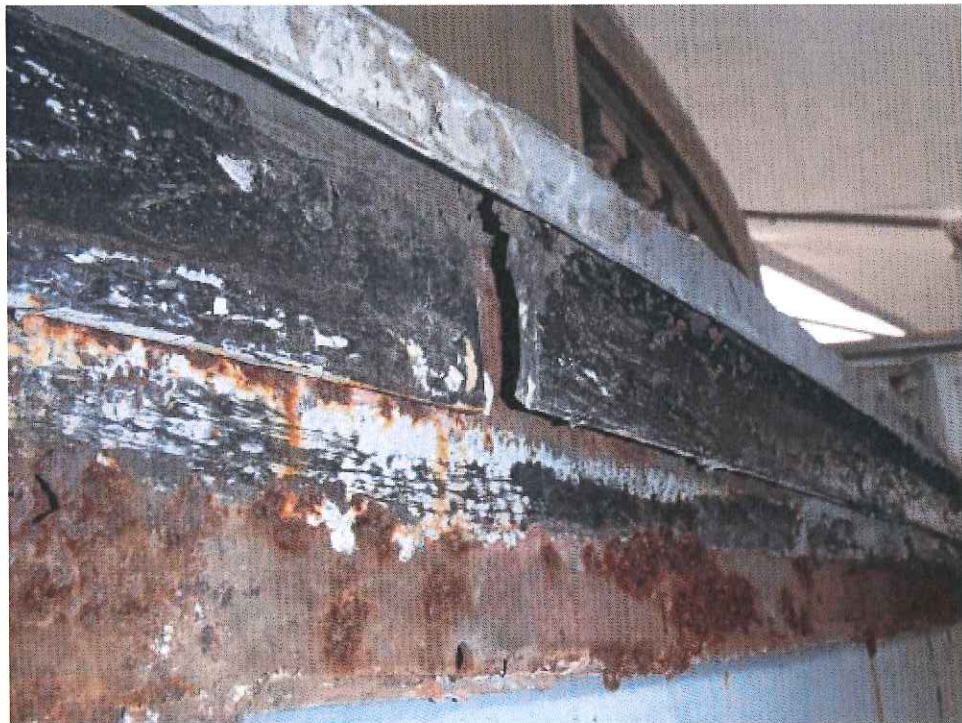
Photo 1.6b: Fibrous strip backing behind gutter.

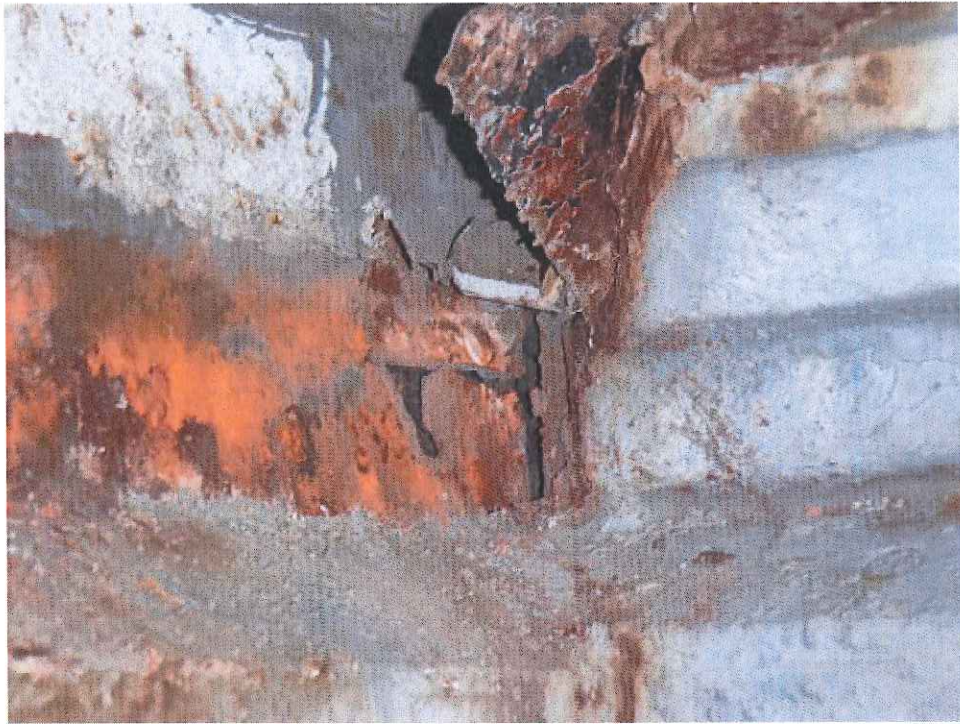
Photo 1.6c: Material loss in vertical plate behind gutter.

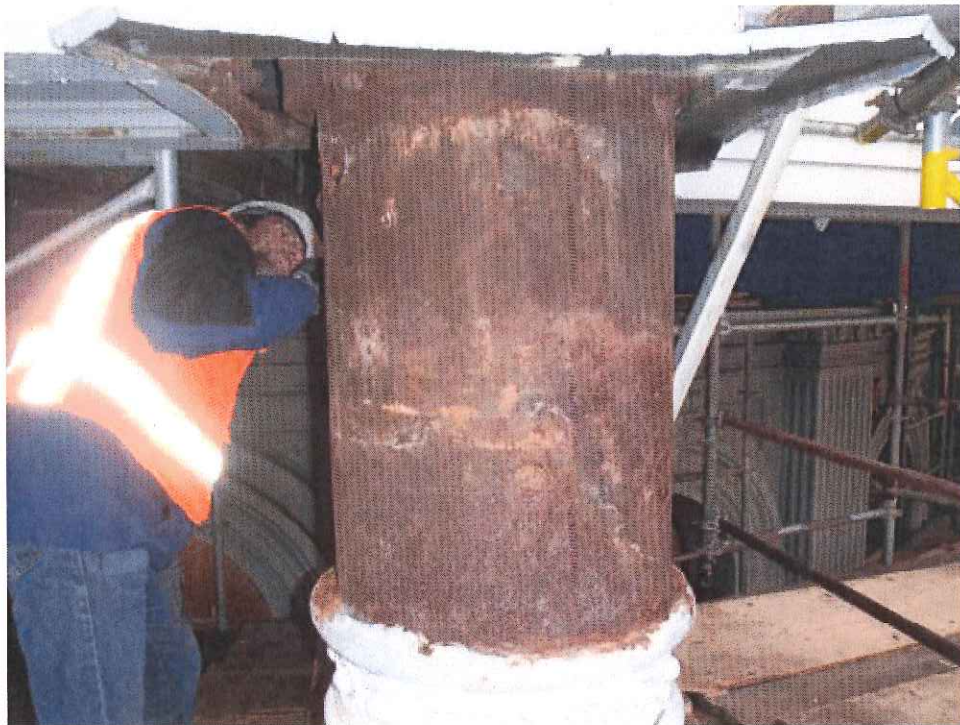
Photo 1.7a: Removed column capital.

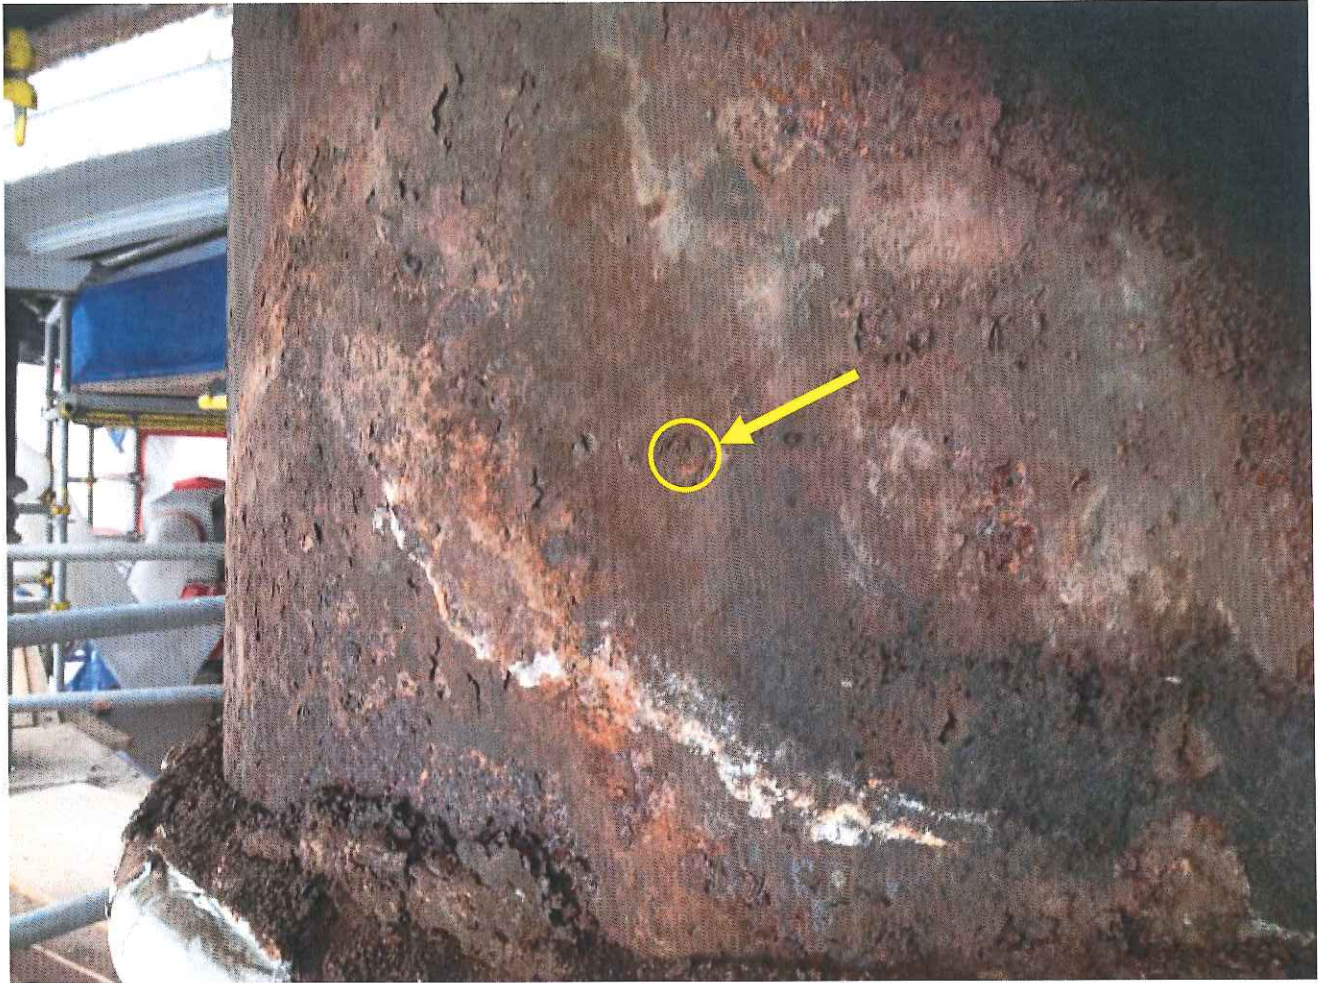
Photo 09.3: Broken bolt to capital on outer column on grid line E

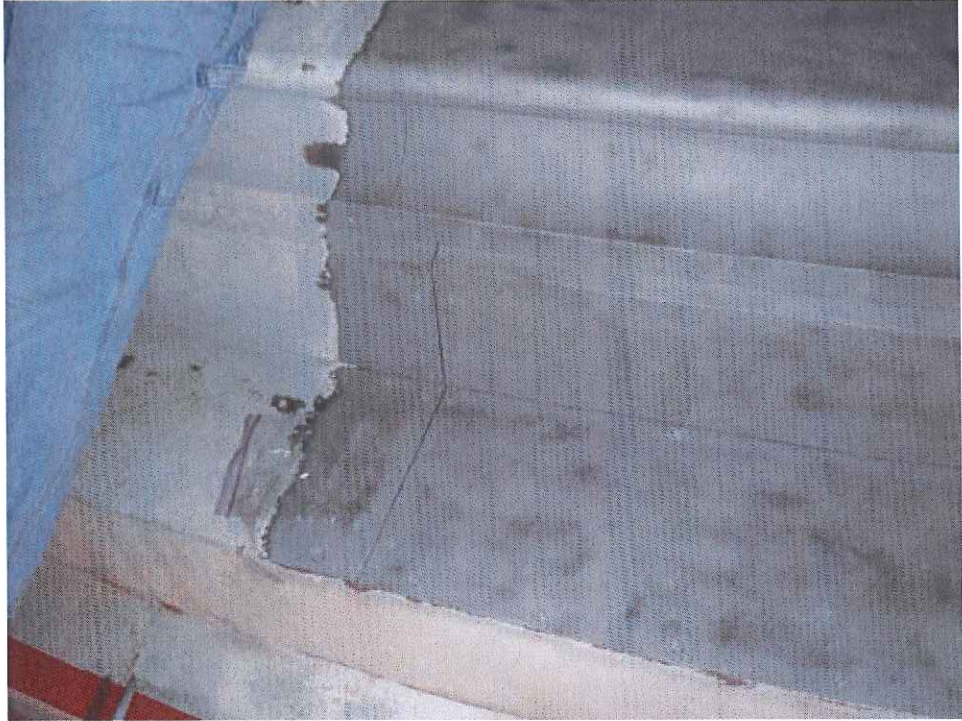
Photo 1.3a: Coatings removal mock-up.

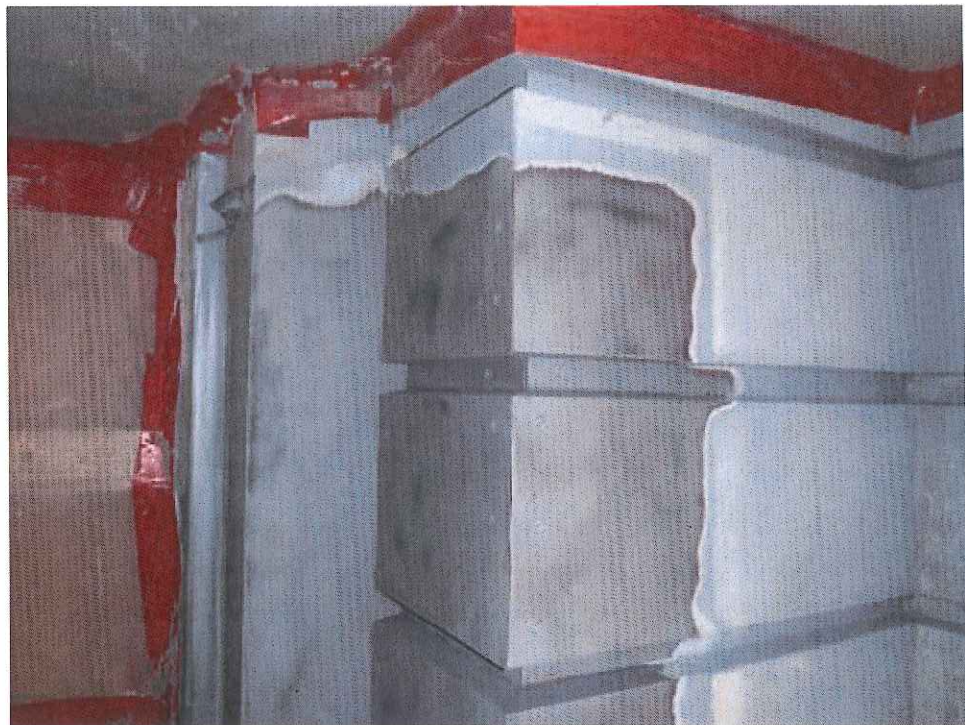
Photo 1.3b: Coatings removal mock-up.

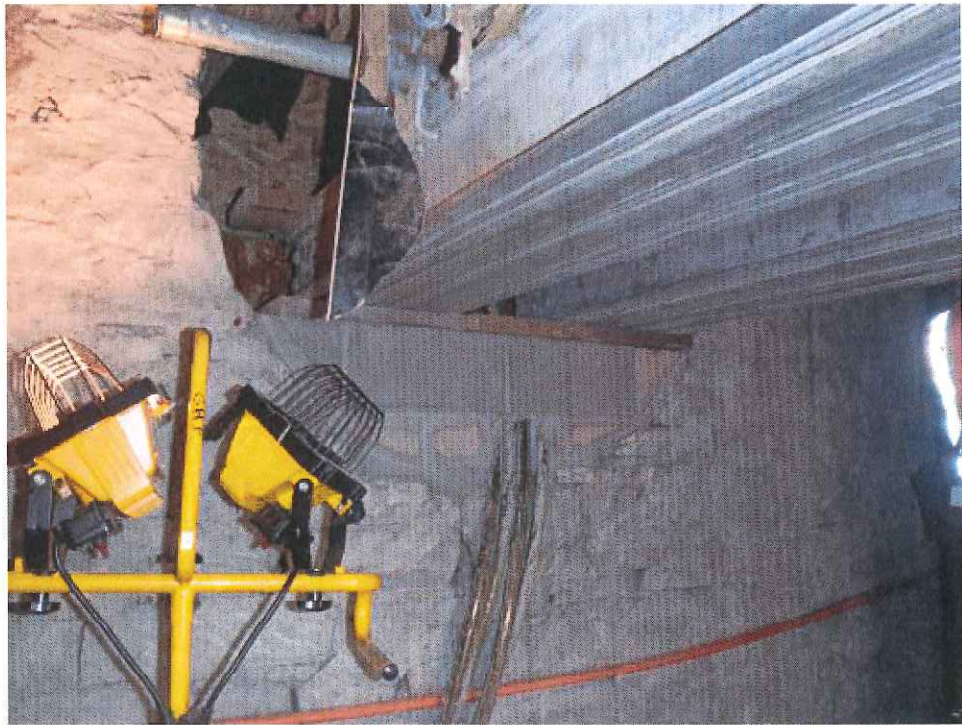
Photo 1.2: Installed radial scaffolding support beams.

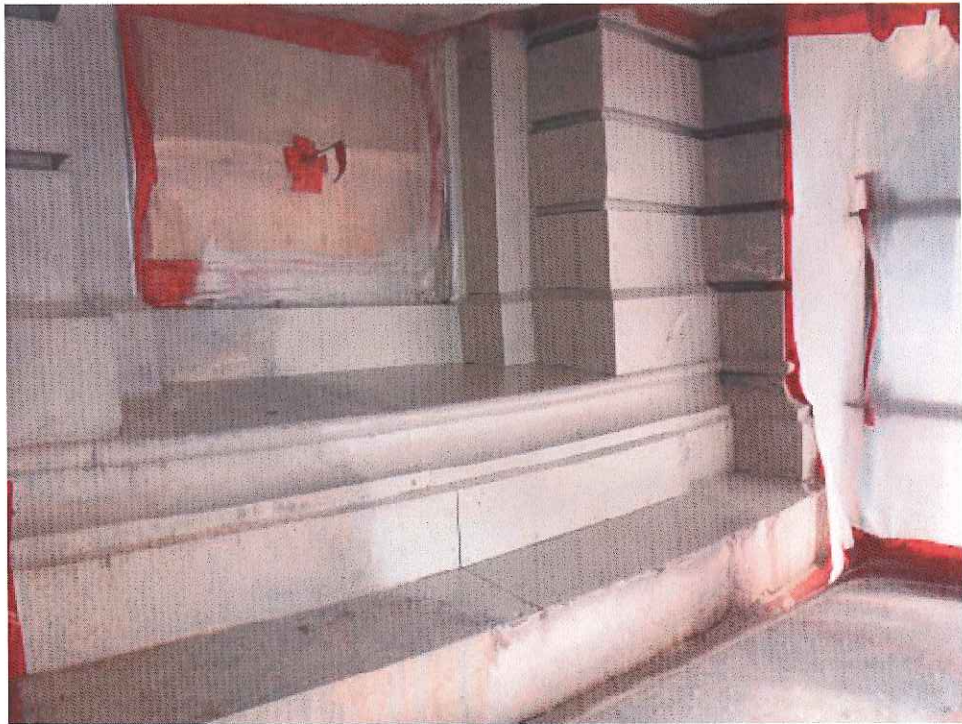
Photo 1.4: Prime coat mock-up.

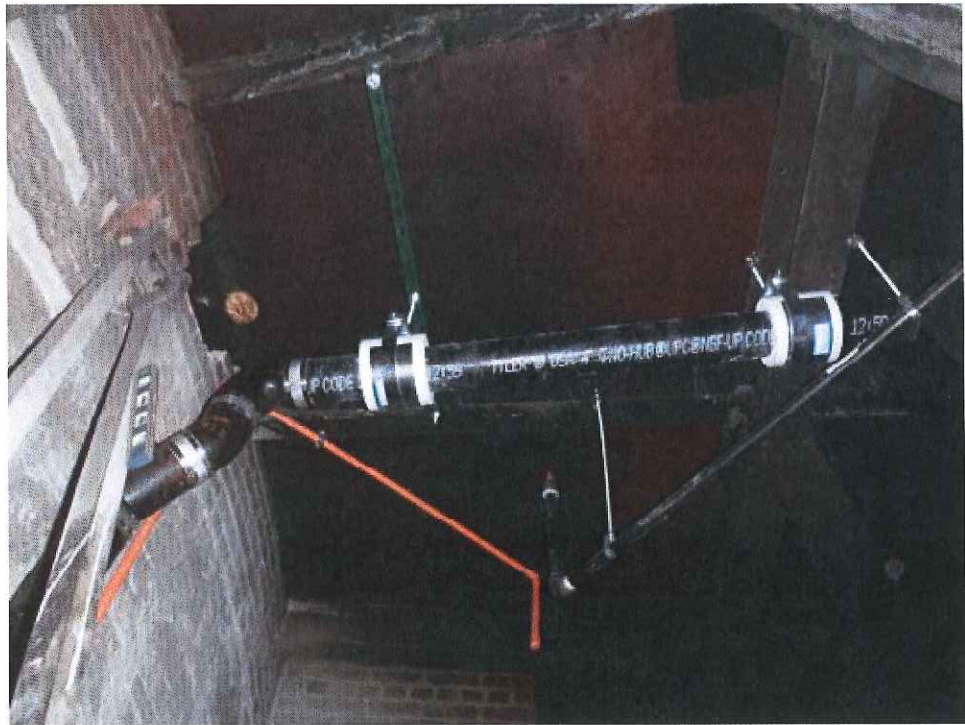
Photo 1.8: Newly installed rainleader.
