**Investigation of Liberty Bell Replica,
Denver, Colorado**

Anthony & Associates, Inc.
P.O. Box 271400
Fort Collins, CO 80527-1400

Atkinson-Noland & Associates, P.C.
2619 Spruce St.
Boulder, CO 80302

May 14, 2013

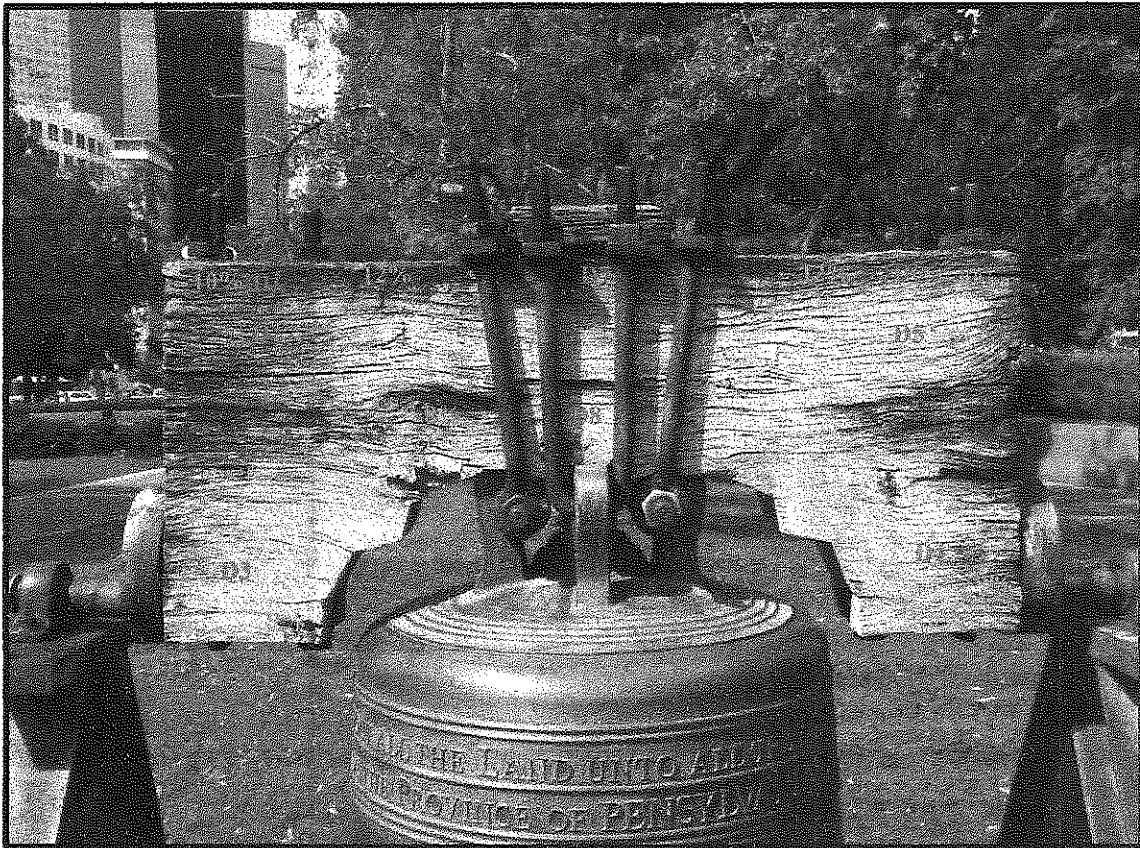
Visual inspection, probing, moisture content measurements, and resistance drilling were used to determine the presence and extent of any wood deterioration at specific locations on the yoke (Figure 1). Visual inspection enables detection of external wood decay fungi or insect activity as determined by the presence of decay fruiting bodies, fungal growth, insect bore holes or wood substance removed by wood-destroying insects.

Figure 1. Liberty Bell Replica, Denver, Colorado. Drilling locations are marked in red, moisture contents in blue.

Prolonged exposure to moisture can cause excessive shrinkage or swelling, checking, loose connections, and decay in wood. Moisture content measurements can identify conditions favorable for the growth of wood-decay fungi. Generally, if the moisture content is less than 20 percent wood-decay fungi are unable to grow. Moisture contents from 20 to 30 percent indicate areas of concern where sufficient moisture is present for fungi to grow but not sufficient to indicate advanced decay. Moisture contents above 30 percent are often an indication of advanced decay with internal voids and / or surface deterioration. Moisture content measurement readings and locations are shown in Figure 1.

Drilling Number	Face	Location	Drilling Direction	Comments
D1	South	4" from west, 2" from top	S-N	2" intermittent internal voids
D2	South	4" from west, 4" from top	S-N	less than 1/2" intermittent internal voids
D3	South	4" from west, 3" from bottom	S-N	no void
D4	South	4" from east, 3" from bottom	S-N	no void
D5	South	4" from east, 4" from top	S-N	1/2" internal void
D6	South	4" from east, 2" from top	S-N	3/4" internal void
D7	South	mid-width, 2" from top	S-N	less than 1/2" internal voids
D8	South	mid-width, 2.5" from bottom	S-N	no void

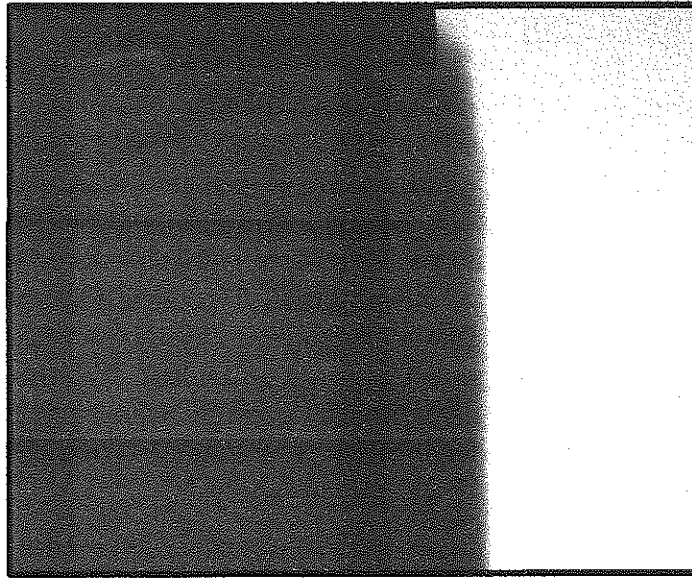
The radiograph of the upper right corner of the yoke shows that the steel rods are in good condition (Figure 3). This is illustrated by the relatively parallel edges of the rods indicating that corrosion has not reduced the cross section. The radiograph of the lower right corner of the yoke shows minor surface corrosion of the two vertical rods, as indicated by the darker areas adjacent to the rods (Figure 4). This corrosion was observed on other rods, typically near the exposed end grain of the wooden yoke where moisture is absorbed into the wood. The surface corrosion may make it somewhat difficult to remove the rods for cleaning during repair of the yoke. Care should be taken to not forcefully remove the rods and risk splitting the wooden yoke. It should be noted that also visible in Figure 3 is the steel ring that is attached to the axle; it is in good condition.

Figure 3. Radiograph corresponding to the setup shown in Figure 2. Note the sharp, parallel edges of the vertical steel rods, indicating no loss of cross section due to corrosion.

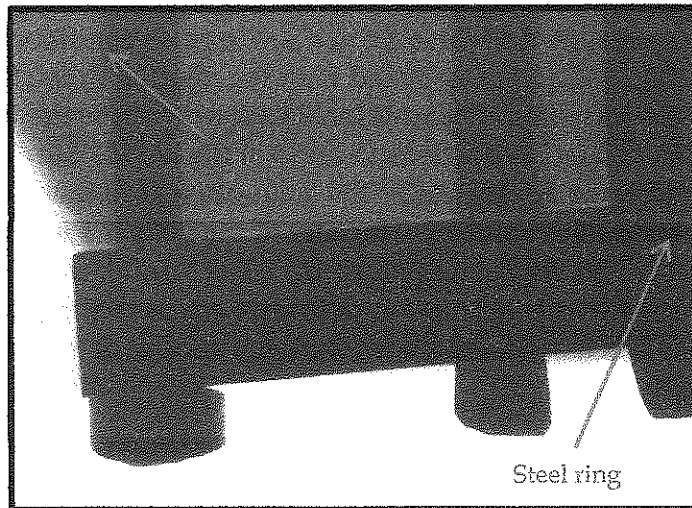
Figure 4. Radiograph corresponding to the area directly below the position shown in Figure 2. Note the dark staining adjacent to the steel rods due to rust accumulation.

Based on the investigation of the wooden yoke, the wood, steel rods, and steel straps are in good condition with minor deterioration due to wood decay adjacent to the metal strap at the top of the yoke, surface weathering of the wood (which produces the silver-gray patina), and minor surface corrosion on some of the steel rods embedded within the yoke. These conditions indicate that there is no need to replace the wooden yoke.

- Corroded steel elements should be cleaned down to bright metal and protected with appropriate coating. A zinc rich primer, e.g. Sherwin-Williams Corothane 1 or equivalent would work.

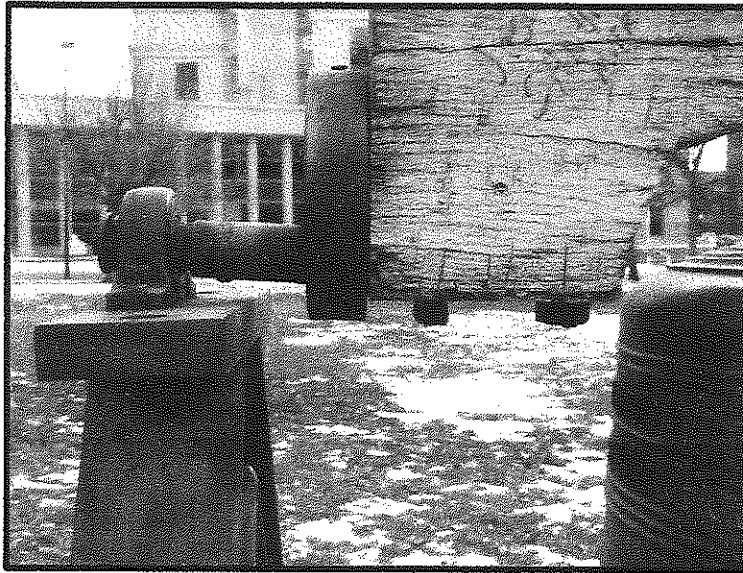
ANA conducted a site visit to the Liberty Bell Replica in Denver to obtain detailed measurements of the Bell support structure and evaluate the overall materials condition. The wood yoke and the steel connections show signs of deterioration due to weathering but are in fair-to-good condition. The steel support frames are mounted in concrete and are in good condition. The main structural concern is associated with the sagging of the Bell, which likely prompted the installation of additional supports below the Bell. Some of the sagging may be related to the deterioration of the wood. However, the primary cause of sagging appears to be the connection failure at where the axles bear on the support frame (Figure). The base of the yoke is supported by a steel bar that cantilevers from the bearing assembly. The cantilever bar is connected to the yoke by through-bolts. Excessive deformations in the hinge connection of the bearing assemblies have caused both axles to shift out of alignment resulting in excessive sagging.

Figure 5. Connection failure at bearing. Both axles have shifted out of alignment resulting in the sagging of the support structure.

- The existing bearing assembly has failed and must be repaired or replaced (see attached conceptual repair drawing). The bearing assembly should be able to resist flexural moments due to the weight of the bell. This could be achieved by using a wider bearing assembly. Two bearings per side

could be used if a single wide bearing was not available that could resist the bending moment due to the weight of the bell.

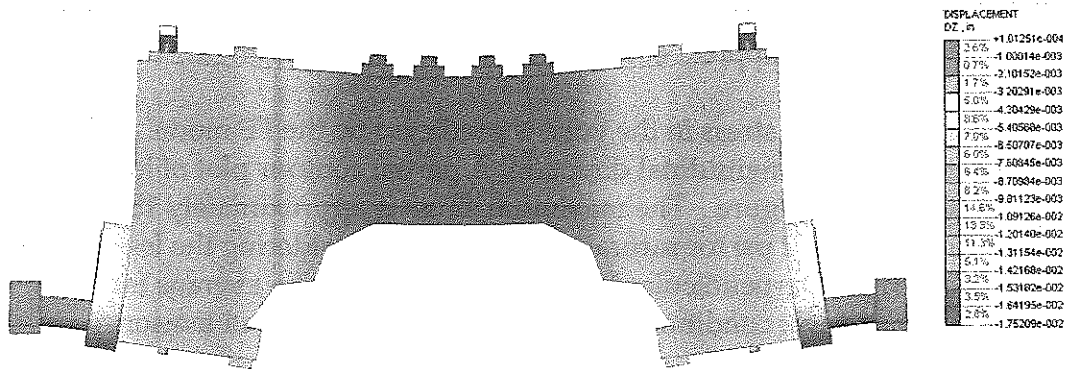
Stresses and deformations in the yoke and the steel components were obtained as a result of the FE analysis. The deformation of the wood yoke under the bell weight is shown in Figure 7. The maximum vertical displacement predicted by the model at the bottom of the yoke is 0.021 in for saturated wood and 0.016 in for dry material. These values account for the deflection of the cantilever steel bar, which is shown (separately) in Figure . The maximum tip deflection predicted by the FE analysis for the steel bar is 0.013 in. These results confirm that the excessive sagging experienced by the bell is primarily due to the connection failure in the bearing assembly.

Figure 7. Vertical displacement (Dz) contour plot showing the deformed shape of the support structure under the bell weight.

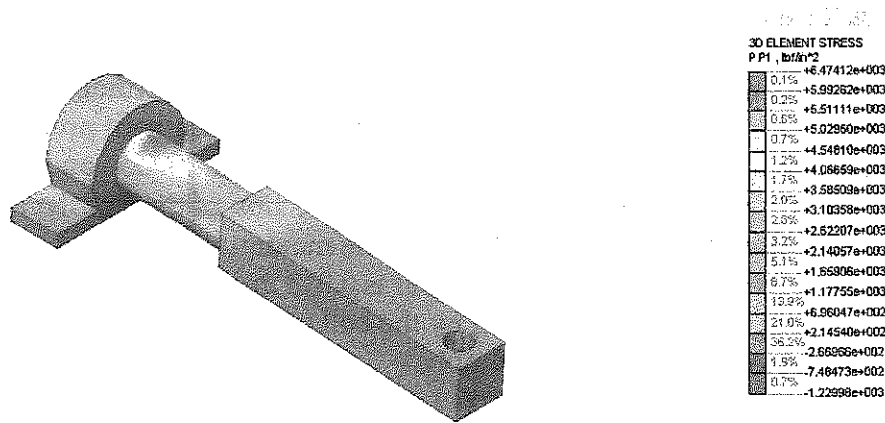
Figure shows the stress distribution in the cantilever steel bar. As the bar bends under the weight of the bell, tension develops in the steel at the top of the axle, which is shown in the figure by the red color. A maximum tensile stress of approximately 6500 psi is predicted by the FE model. When comparing this value to the material strength, defined as the maximum stress that the material can carry without damage and equal to 36,000 psi for steel, a factor of safety of 5.5 is found. The factor of safety is defined as the ratio between the material strength and the applied stress. Based on these results, the cantilever steel bar has enough strength to safely support the bell.

Figure 9. Principle stress (P1) contour plot in cantilever steel bar. Maximum stress (approx. 6500 psi) is below material strength.

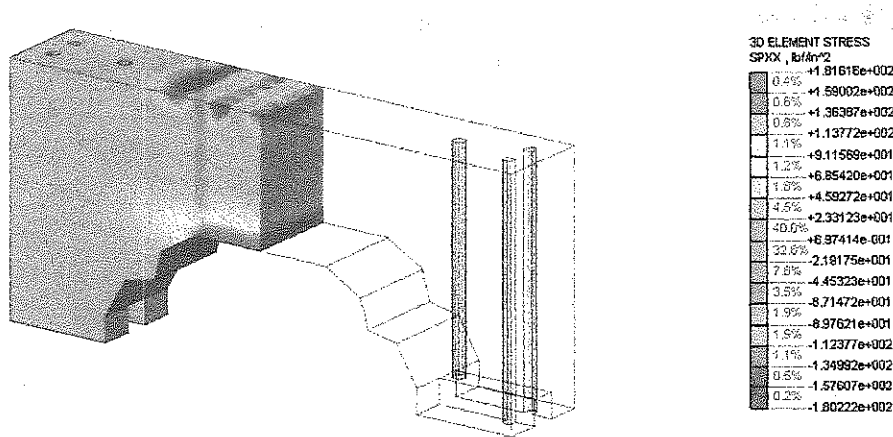
The maximum tensile stress in the yoke is predicted by the FE model at the bottom fibers in the longitudinal direction. A partial contour plot of longitudinal stresses is shown in Figure . The maximum stress is approximately 180 psi for dry condition and 172 psi for saturated condition. Considering the lesser value of tensile strength (perpendicular to grain) for the wood, an average factor of safety for dry and wet conditions of 4.5 is found for the yoke in tension.

Figure 10. Partial longitudinal stress (Sx) contour plot in yoke (dry condition). Maximum tensile stress at bottom fibers (approx. 180 psi) is below material strength.

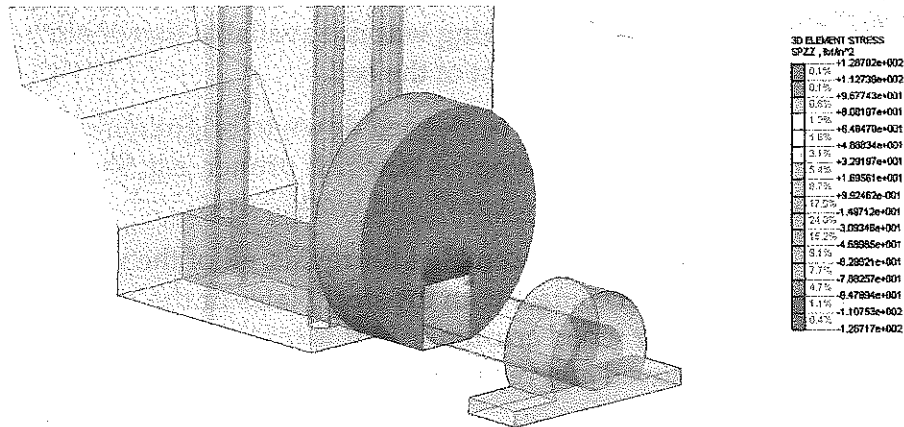
The maximum compression stress in the yoke was found at the bearing interface with the cantilever bar, as shown in Figure . Maximum values predicted by the model were equal to 130 psi for dry condition and 105 psi for saturated condition, resulting in factors of safety of 8 and 6 respectively.

Figure 11. Vertical stress (S_z) contour plot in protruding wood ring (dry condition). Maximum compression stress at bearing interface with cantilever bar (approx. 130 psi) is below material strength.
