Building Name: Meyer

### **B. OBSERVATIONS**

Conditions assessed on April 18, 2014, and April 19, 2014.

**COLORADO DEPARTMENT OF HUMAN SERVICES  
CAMPUS AT GRAND JUNCTION  
FACILITIES ASSESSMENT**

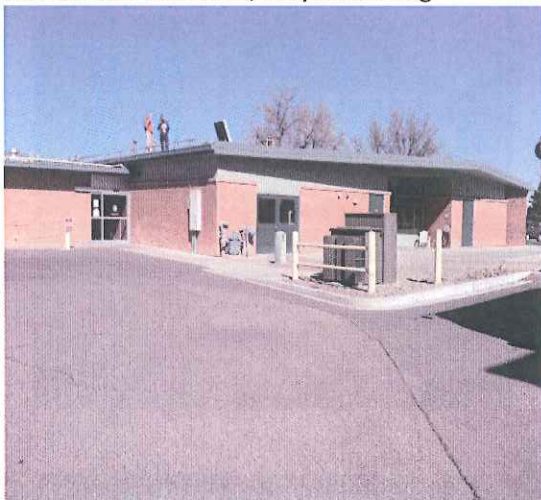
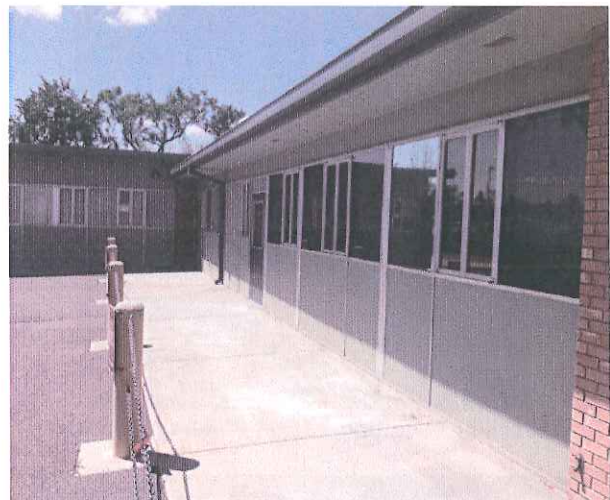
Typical exterior condition, Meyer Building

**Skin:** The building shell is a combination of brick and mortar, stucco and metal panel/window wall system. The brick and mortar is in good condition, there is no noticeable brick or mortar deterioration. The metal wall panels have no insulation value. The stucco is cracked and is in need of replacement

**Windows:** The windows are obsolete single pane windows and require replacement.

**Exterior/Entry:** The doors are a combination of hollow metal, glass and automatic doors, all of which are functional. The door frames are hollow metal and are in good condition despite a few dents and chips. The metal doors, aluminum/steel thresholds and closers are in good condition. The glass doors are in good condition and all automatic doors are well maintained and functional. The hardware is brushed aluminum paddle, the handles and panic hardware are functional. For code compliance, see Meyer Building Code section.

**Skin:** Replace all exterior stucco.

**Windows:** Replace 100% of the windows, quantity of 64, and lower all window sills in the dorm rooms, quantity of 35.

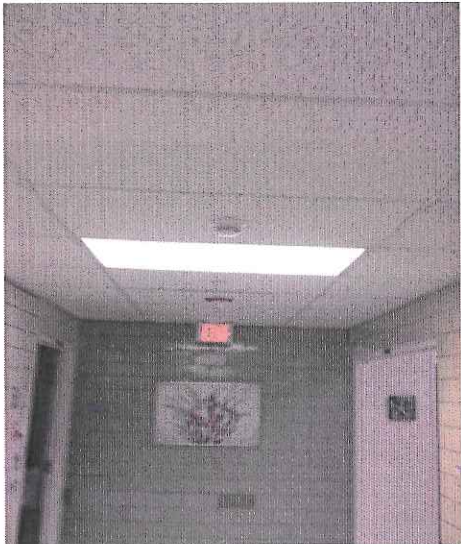
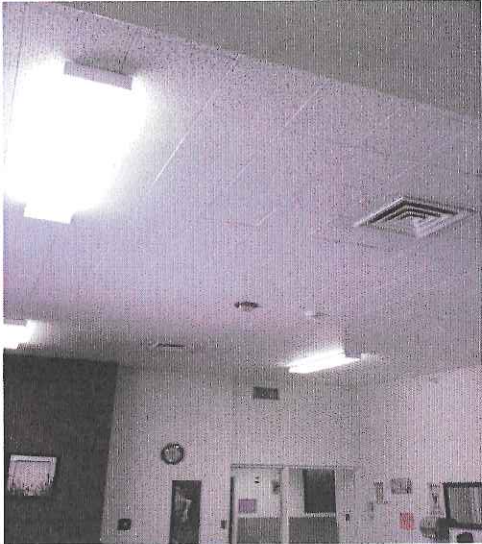
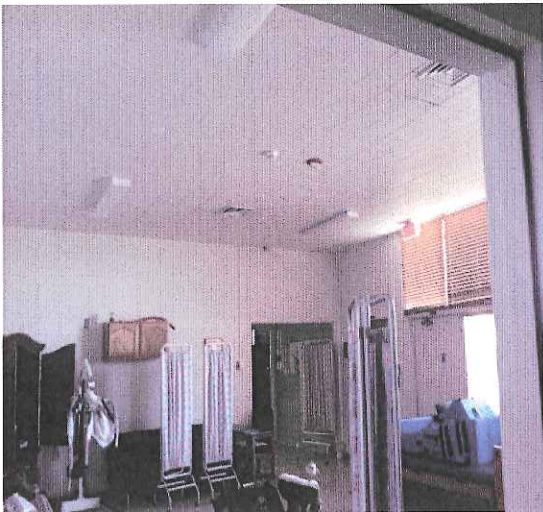
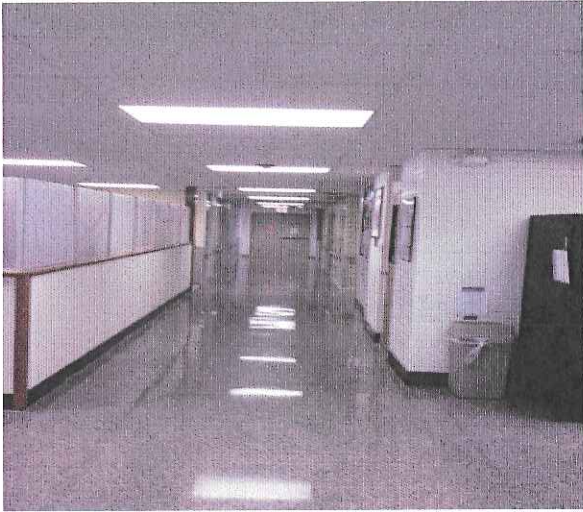
Typical ceiling condition, Meyer Building

**Ceilings:** 60% of the ceilings are plaster ceilings and glued acoustic tiles, they are damaged by roof leaks and are either sagging or loose. 40% of ceilings are 2x4 dropped ceiling and need minor repair.

**Ceilings:** Provide a new 2x4 drop down ceiling at all hard lid and glued tile ceilings, 60% of total ceiling area (16,118 square feet). Provide new 2x4 light fixtures in the associated ceiling, quantity of 161. Repair 20% of existing 2x4 drop down ceilings (2,500 square feet).

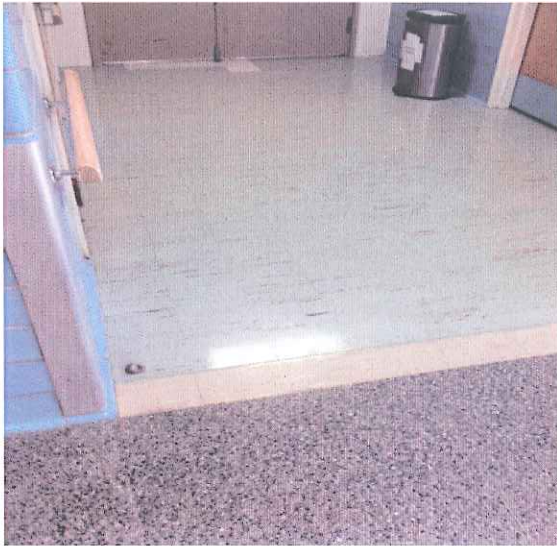
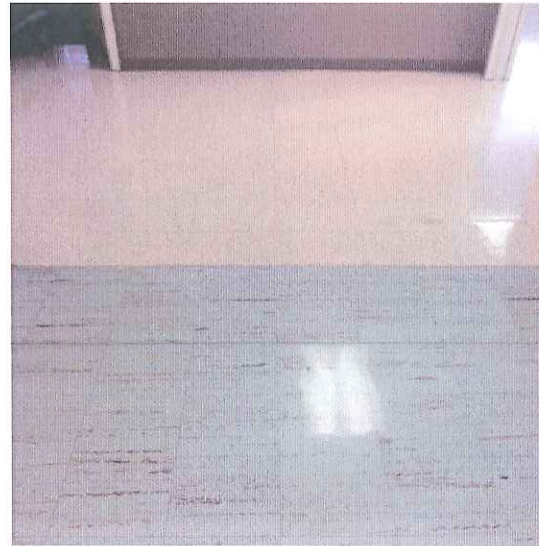
Typical floor condition, Meyer Building

**Flooring:** The flooring in the Meyer building is a combination of Terrazzo flooring, asbestos tile and carpet. The Terrazzo flooring has cracks due to previous slab settlement. The carpet is only in a few offices and is worn and in need of replacement. 40% of the flooring is asbestos tile, which is cracking and will require abatement and encapsulation or replacement.

**Flooring:** Abate and encapsulate or replace all flooring containing asbestos, 40% of the total floor area (10,745 square feet).

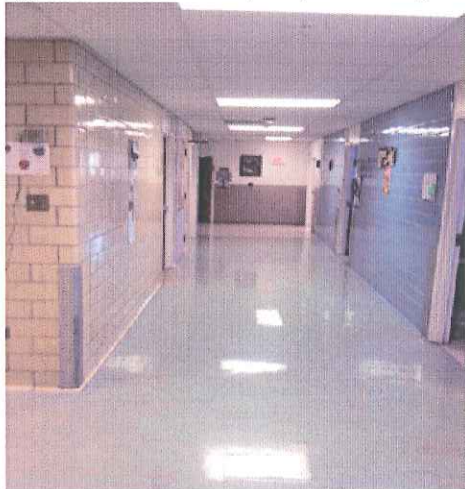
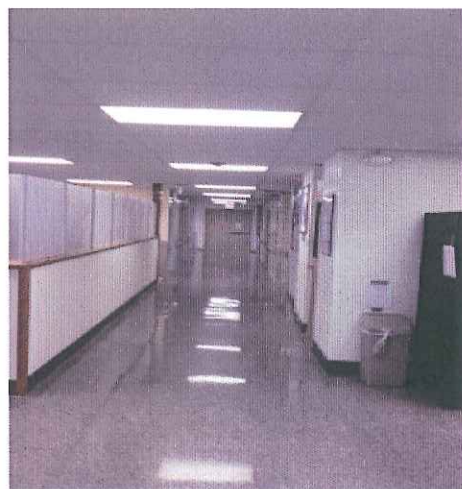
Typical wall condition, Meyer Building

**Wall Finishes:** 80% of the wall finishes throughout the building are glazed concrete block. Some bathrooms have ceramic tile while others have painted gypboard. The glazed concrete block is in good condition except where there is cracking due to previous slab settlement. The ceramic tile in specific bathrooms is in good condition. The painted gypboard is also in good condition. The entire building could use a well-designed wall protection system.

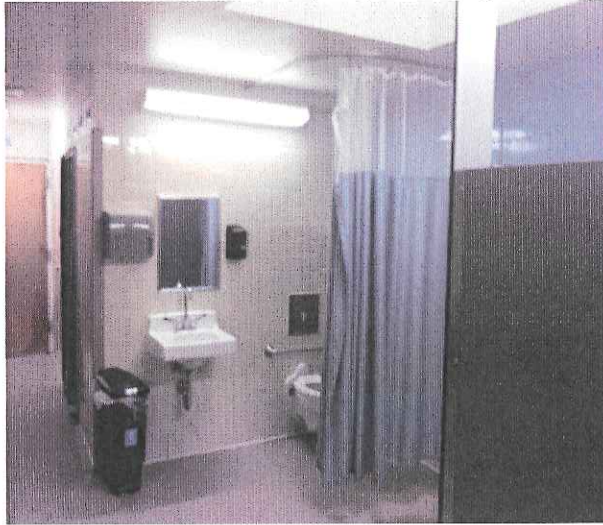
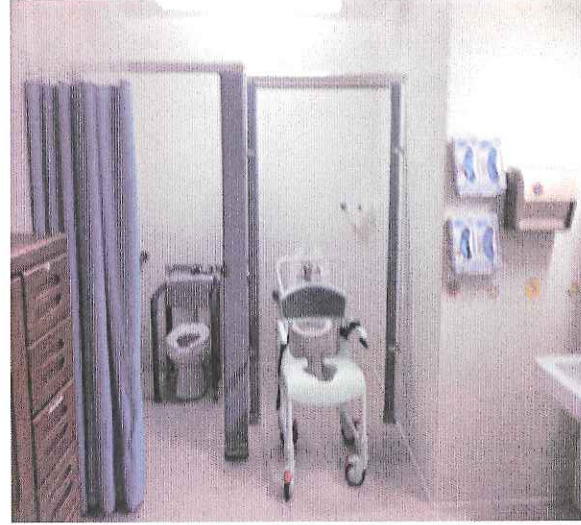
Typical Bathroom condition, Meyer Building

**Bathrooms:** There are a number of various bathroom types in the building. Some are designated for staff, some for clients and others are bathrooms for specific client needs.

**Bathrooms:** Provide ADA compliant bathrooms as needed, see the Meyer Building Code section.

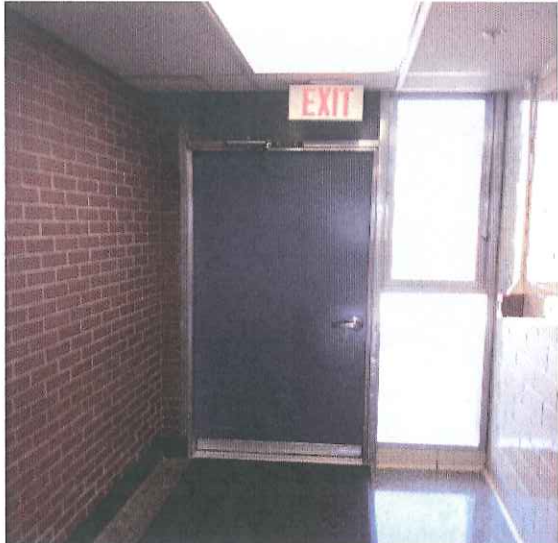
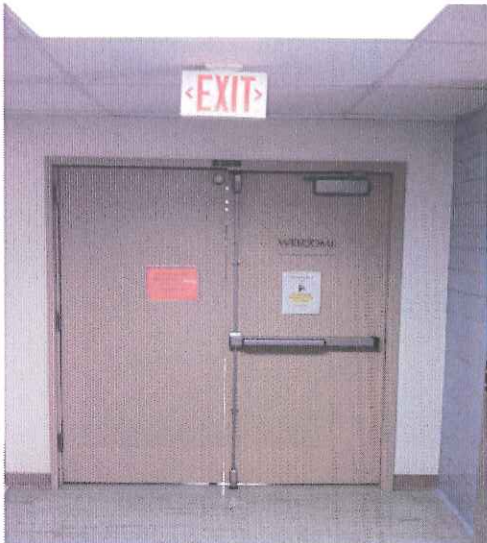
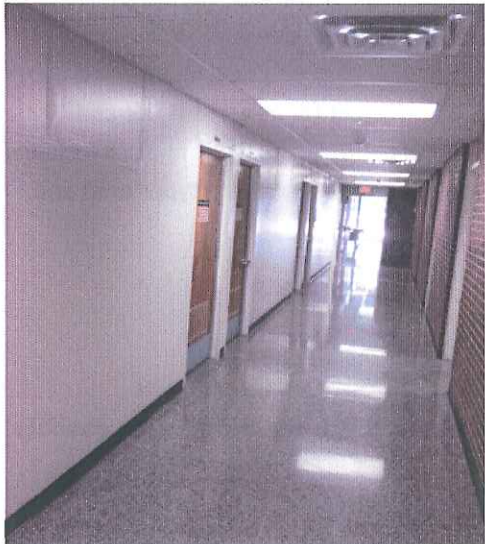
Typical door conditions, Meyer Building

**Interior Doors:** There is a mix of wood and metal doors with hollow metal frames, all of which are functional. The wood and metal doors are in good condition with some dents and chips. The hollow metal frames are in good condition with some damage as would be expected for current use. The double metal security doors between the building wings have chips and dents but have been well maintained and seem appropriate for their location and use. The hardware is brushed aluminum finish, the paddle levers and panic hardware is in good condition.

**Doors:** Replace two automatic doors and a double glass door at the southeast corner of the building.

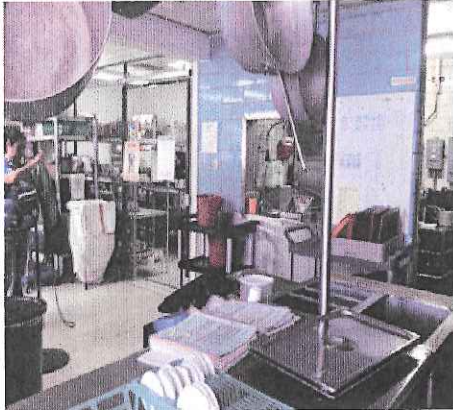
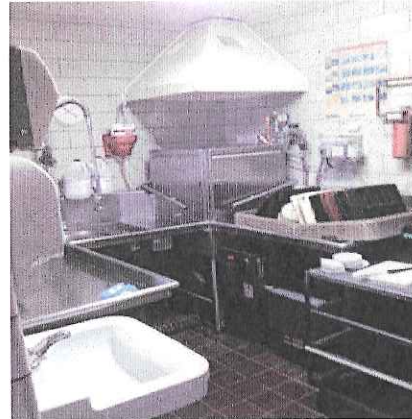
Typical kitchen condition, Meyer Building

**Kitchen:** The kitchen has commercial equipment, stainless steel shelves, counters, sinks, quarry tile floor, glazed block walls and vinyl ceiling, all of which is in good condition.

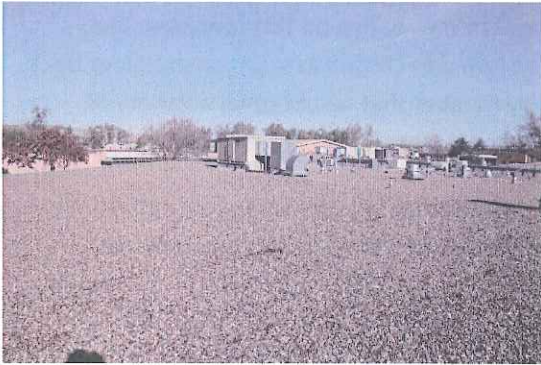
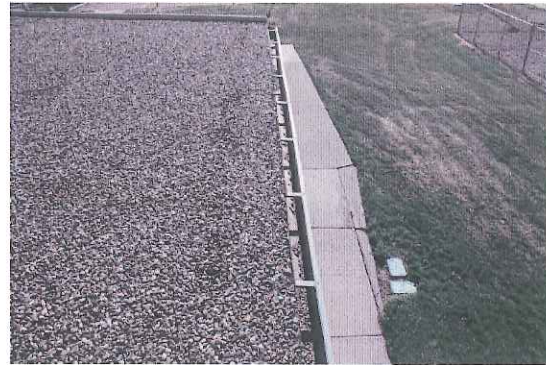
### Deck 1

- Roof Membrane: The roofing system on this deck area is in excellent condition for its age. No repairs are required on this roofing at this time.
- Roof Flashings: The roof flashings were replaced in 2007 when the adjacent roofing was replaced. Some of the roof cement three course corners are cracking, but the flashings remain watertight and do not require repair at this time.

- Roofing Sheet Metal: The roofing sheet metal flashings were found to be in good condition. No gutter repair or sheet metal flashing repair is needed.
- Service Life: The asphalt BUR system appears to be performing as expected. This roofing system has a remaining service life of 7 to 10 years.
- Photos: The photos that follow provide an overview of the roof and its flashings.

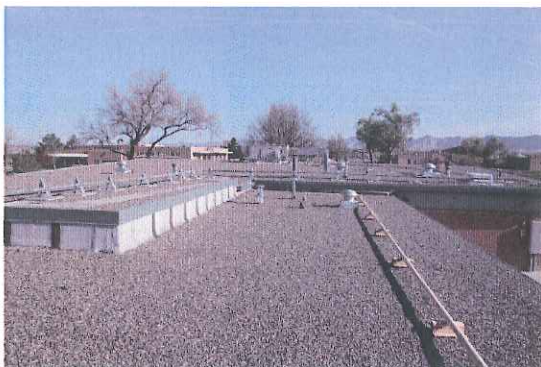
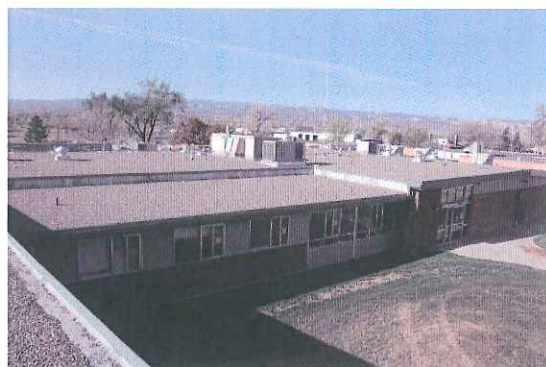
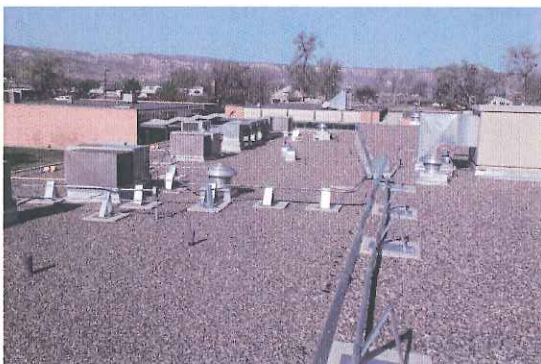
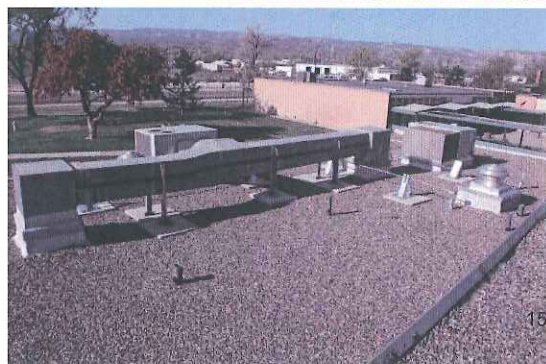
### Decks 2 Through 7

- Roof Membrane: The roofing systems here are newer than that found at Deck 1 and they were found to be in excellent condition. No items requiring repair were noted.
- Roof Flashings: The roof flashings again were in great shape. No repairs are needed on these flashings at this time.
- Roofing Sheet Metal: The roofing sheet metal flashings and gutter system were found to be in good condition. No repairs are needed on these items at this time.
- Service Life: These asphalt BUR systems appear to be performing as expected. These roofs have a remaining service life of 20 to 25 years.
- Photos: The photos that follow provide an overview of some of the roof areas.

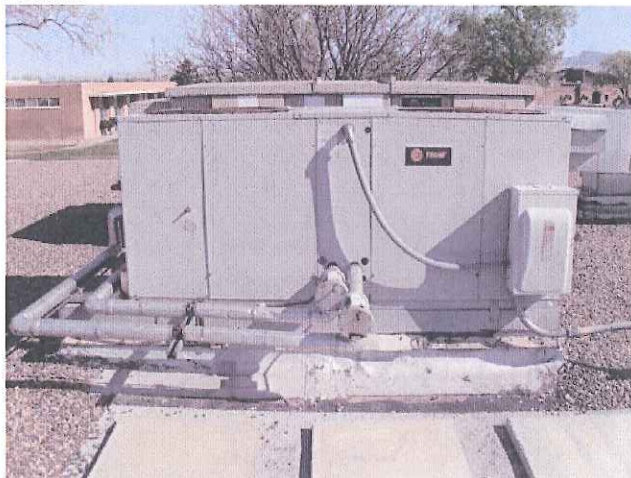
Photo 1 – Typical Rooftop HVAC Unit.

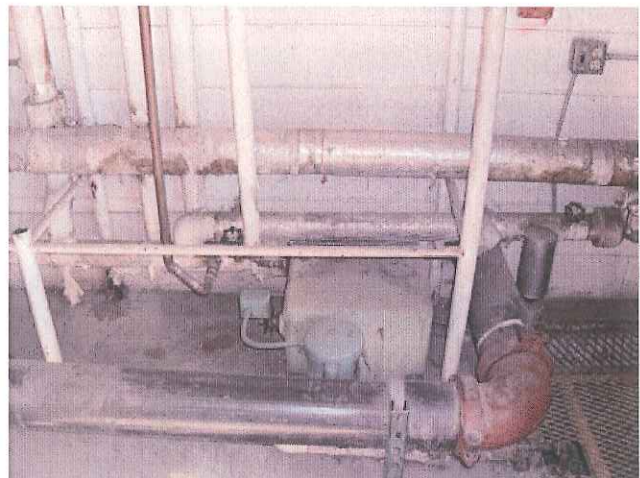
Photo 2 – Steam Condensate return pump

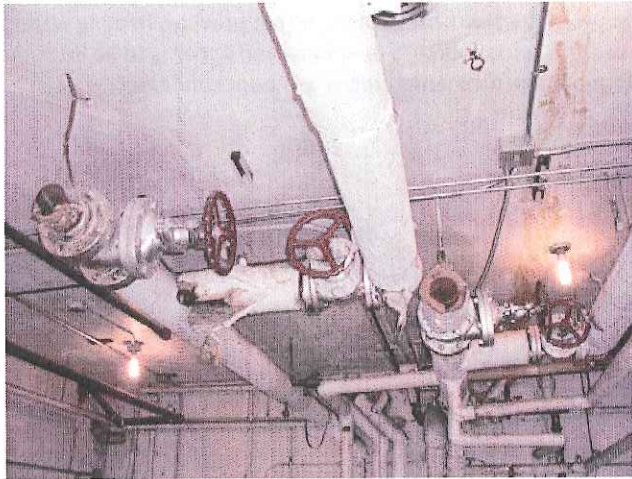
Residents units and entry areas have baseboard heat. The steam-to-hot water heat exchanger that provides heating water to these units appears to be in poor condition. The steam condensate return pump is functional and appears to be in adequate condition. The heating water and steam piping insulation in the mechanical room is in poor condition.

Photo 3 – Mechanical room piping insulation – typical

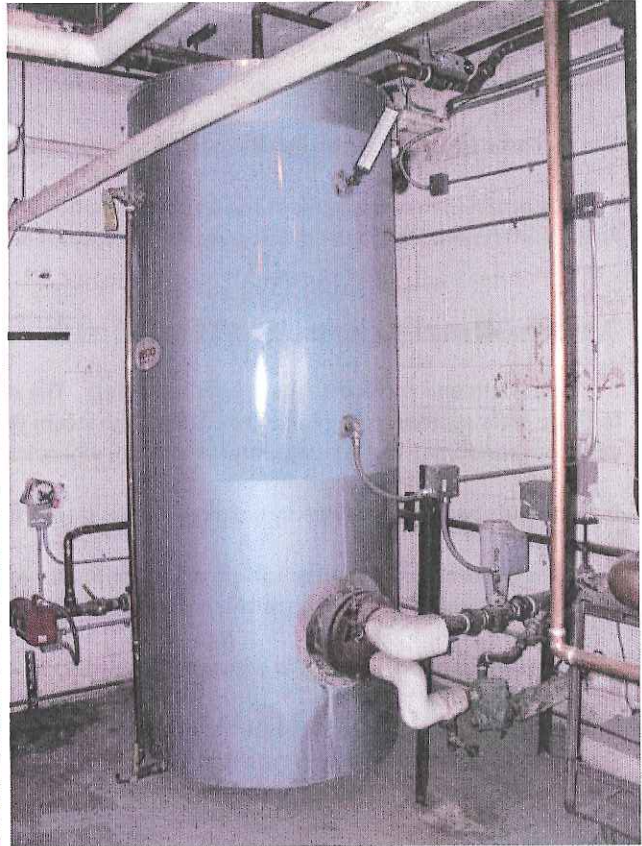
Photo 4 – Domestic water heater

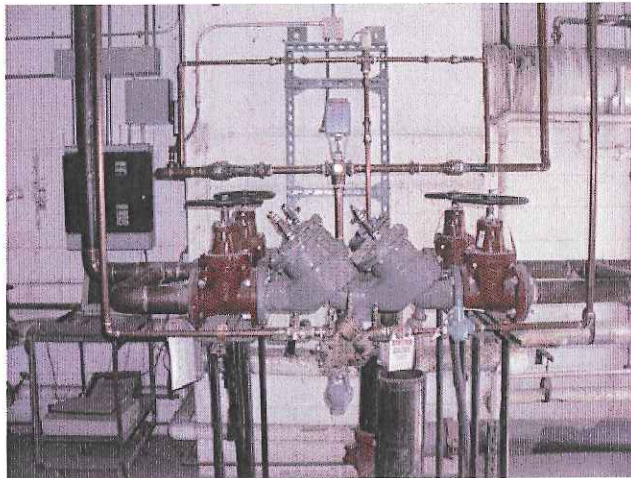
The building water entry backflow preventer appears to be in good condition.

Photo 5 – Backflow preventer.

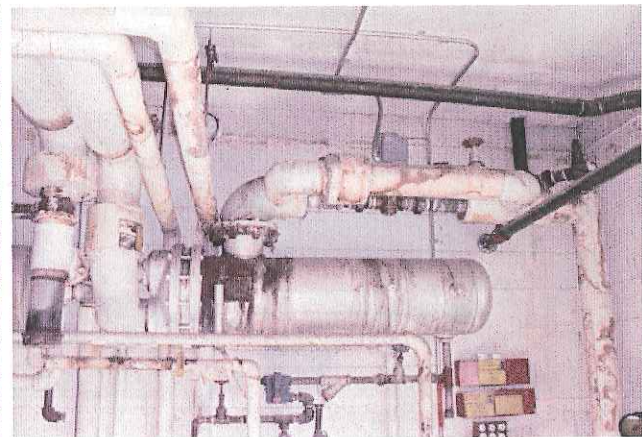
Photo 6 – Steam-to-Water Heat Exchanger for building heating water.

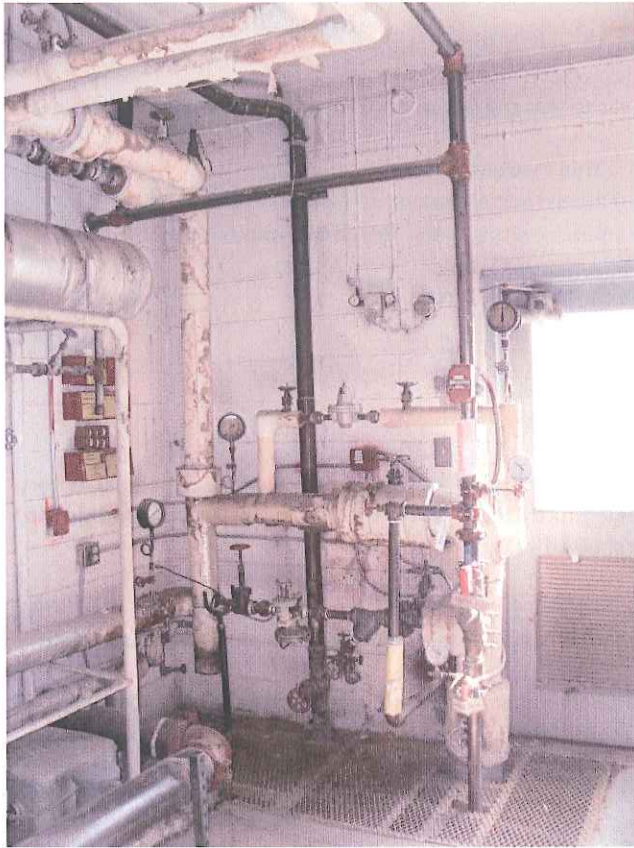
Photo 7 – Steam piping entry with insulation.

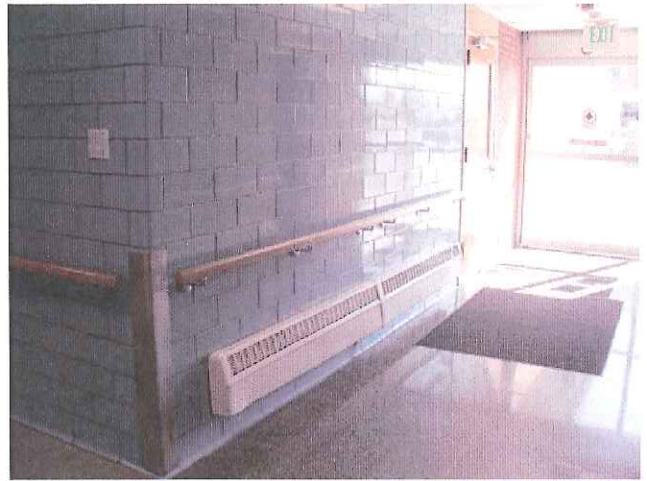
Photo 8 – Entry vestibule baseboard heating unit.
