FOUNTAIN CREEK WATERSHED

FOUNTAIN CREEK WATERSHED SOLUTIONS

FOUNTAIN CREEK WATERSHED DEMONSTRATION PROJECTS

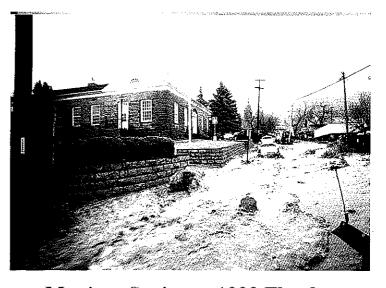
Manitou Springs - 1999 Flood

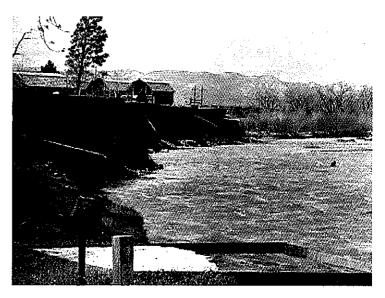
Bank erosion on Fountain Creek

- Large elevation changes
- Flashy rain events
- · Highly erosive soils
- Limited roots to secure soils

- Erosion
- Sedimentation
- Flooding

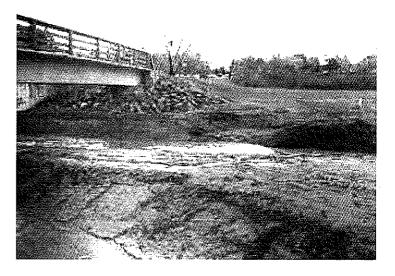
Sedimentation under a bridge

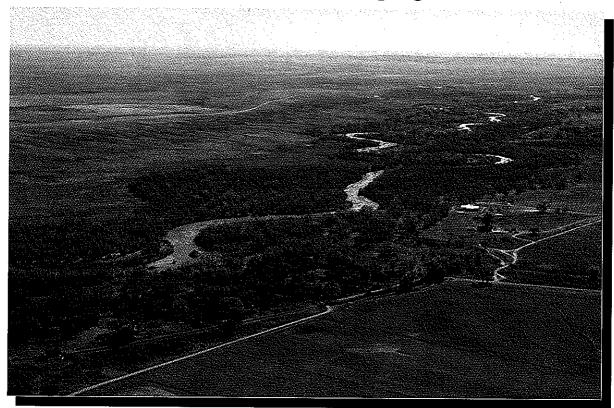
Healthy stretch of Fountain Creek in Southern El Paso County

- ♦ Wide floodway connected to creek spreads floods out & reduces its destructive power, lessens erosion & sedimentation
- ♦ Appropriate sinuosity (curviness) slows down creek flows, lessens erosion & sedimentation
- **♦** Maintain vegetative growth − holds together creek banks
- ♦ Wetlands increases water quality, acts as sponge to reduce flood flows
