**Investigation of Liberty Bell Replica,
Denver, Colorado**

Anthony & Associates, Inc.
P.O. Box 271400
Fort Collins, CO 80527-1400

Atkinson-Noland & Associates, P.C.
2619 Spruce St.
Boulder, CO 80302

May 14, 2013

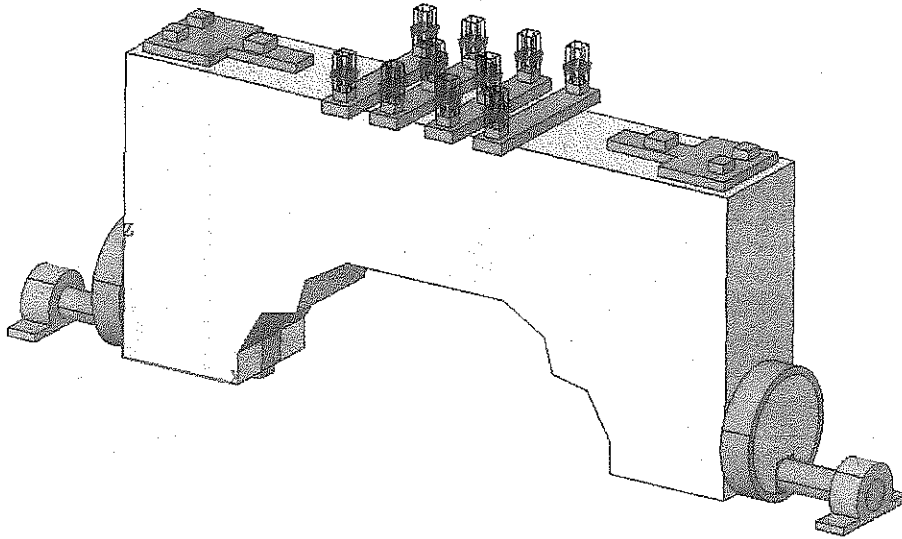
A 3D model of the support structure was created using a finite element program. The geometry is shown in Figure and includes all the main components of the structure. In the computer model, the structure is divided into small elements that are connected to each other. Three-dimensional solid elements were used to model the wood yoke and the steel hardware. Bar elements were used to reproduce the steel rods while special surface elements, called interface elements, were employed to model the contact between steel and wood, allowing the two materials to move independently. Yield strength of 36 ksi and elastic modulus of 28,000 ksi were adopted for the steel. Material properties used for the yoke are summarized in Table 2. Both green and dry properties of White Oak were used in the analysis to represent the behavior of the wood yoke under saturated (green) and dry (12% moisture content or less) conditions. The estimated weight of the Bell is approximately 2080 lb. This load is equally divided among the ten nuts connecting the bell to the top steel plates.

Figure 6. 3D Finite element model of bell support structure. Vertical loads at the top of the structure produced by the bell weight are also visible.
