Plachy Hall HVAC

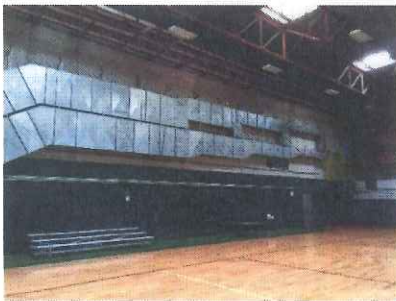
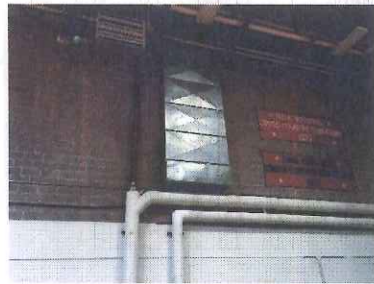
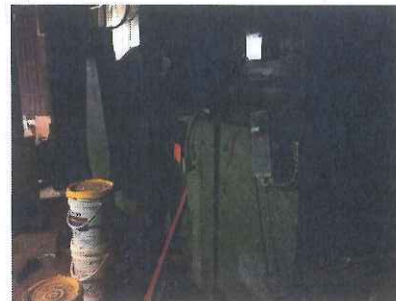
Air Handling Units

- 1963 original air handling equipment
- systems are failing and when operable inefficient
- Three different building automated systems (BAS) control the building.
- Antiquated pneumatic controls have failed and continue to fail
- Air handling units are out of balance and need replaced
- Steam heating coils are tube inside of tube they are brittle and continue to fail.

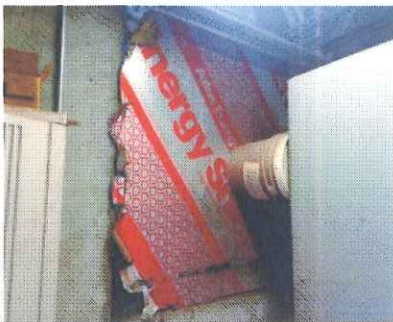
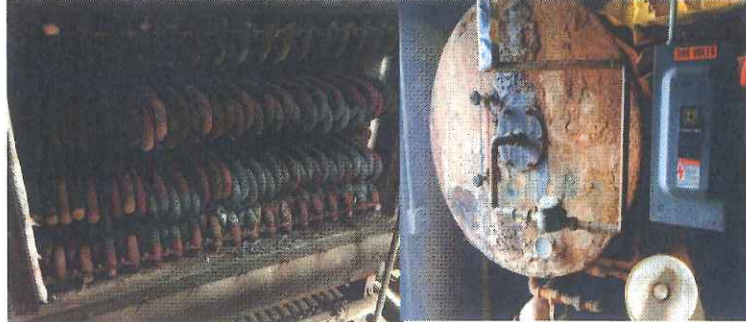
**Boilers**

- In 1997 four boilers were installed they are reaching their end of life cycle.
- Three different mechanical systems heat the building (hot water, glycol and steam)
- The glycol system continues to leak due to acidity caused by the heat exchanger overheating the glycol. This stems from lack of controls.
- Steam injector needs replaced Boiler tubes are corroded and need replaced.
- Controls are needed for the boiler room air intake. Boilers continue to freeze.
- Boiler tubes are corroded with silica that clog the steam from flowing causing them to melt.

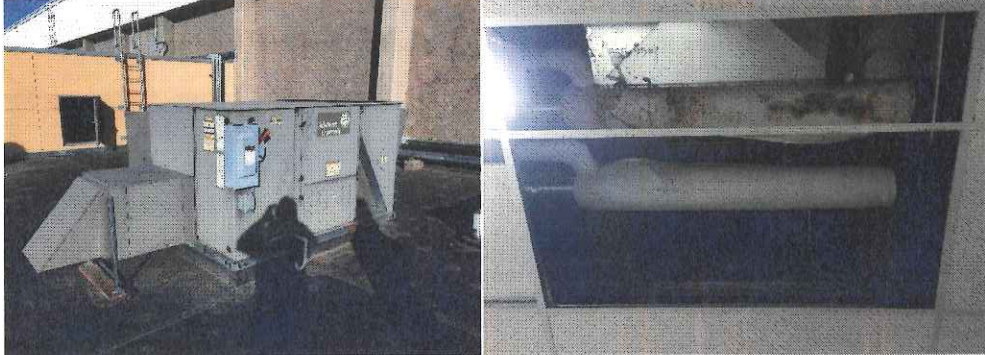
- Roof top units were designed to burn natural gas. They were converted and reconfigured to a steam glycol units. There are no accurate operation and maintenance manuals for these roof top heat sources. Maintenance is very difficult.
- Glycol within this system has overheated and created acidic problems. These problems cause continual maintenance (replacing pumps, valves and seals.)
